**Flood Control Project Maintenance
Levee Inspections**

Fall 2018 Levee Maintenance Deficiency Summary Report

Sacramento River Basin

Reclamation District No. 0010 Honcut

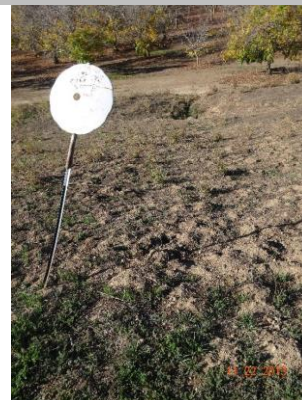
Photo 2 of 3 : UCIP_FA_2018_27773_51460.jpg

View of waterward side--burrow activity present on slope.

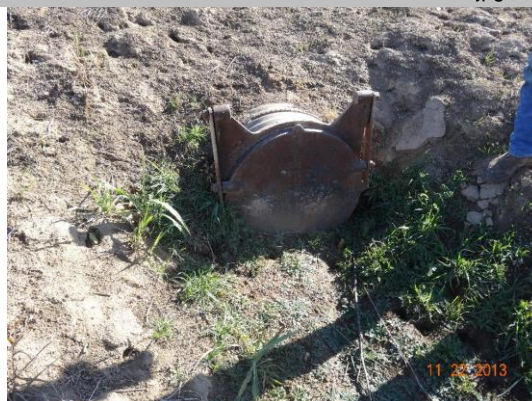
Photo 3 of 3 : UCIP_FA_2018_27773_51464.jpg

View of gate on waterward side.

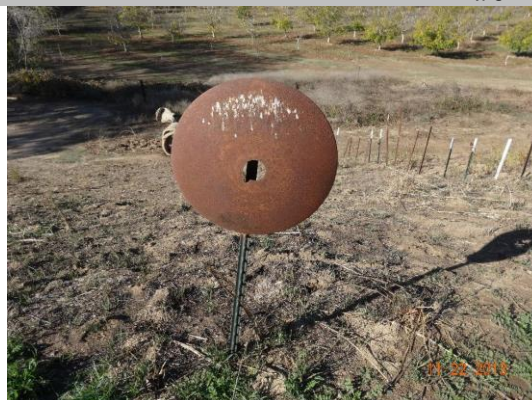
Photo 1 of 3 : UCIP_FA_2018_52889_44658.jpg

Comment Code						
Inspector Comment						
FS_ID:52889 DS_ID:21284 EP_NO: N/A Repair Type: Non-Urgent Crossing Status: Found UCIP Comments: 04/30/2013 Remove concrete piece preventing complete closure of screw gate on landward side. This crossing is referenced in the USACE Periodic Inspection as item USACE_CESPK_HON2_2013_p_0152. (DWR UCIP - O. Magana) FIELD_STRUCT_DESC: 36-inch corrugated metal gravity drainage pipe through the levee, 24 feet below the crown. Corrugated metal cutoff wall around the pipe at each shoulder. Flap gate on the waterside (WS) end. Slide gate on the landside (LS) end. Concrete headwall at each end. [Additional Reference(s): DWR Levee Log, 2005. USACE Sacramento O&M Manual 151, May 1953, (Station 259+76)]. FS Date: 4/30/2013

Marker visible on waterward side.

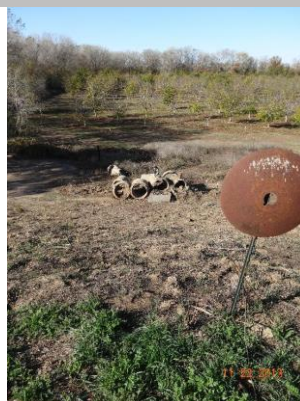
Photo 2 of 3 : UCIP_FA_2018_52889_44657.jpg

Overview of waterward slope--barrier placed at toe to discourage damage to crossing.

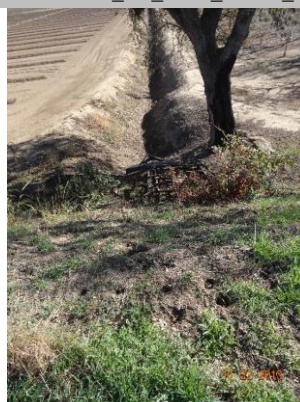
Photo 3 of 3 : UCIP_FA_2018_52889_44656.jpg

View of landward side--barrier used to discourage damage to crossing near toe.

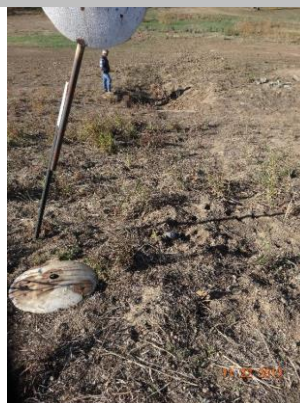
Photo 1 of 1 : FA_2018_RD0010_164_7_20180918_00001.jpg

LM Start	3.60	Rating **	M	Issue No.	7
LM End	3.60	Issue Type +	Ma	Location *	WS
Category	Earthen Levee			GPS Latitude/Longitude	
				Start	End
Item	Animal Control			39.215338 °	39.215338 °
				-121.610751 °	-121.610751 °
DWR ID	DWR_RD0010_02_s_2016_7				
Comment Code					
A3 : No rodents visible, but rodent burrows visible; need to backfill and compact or grout burrows.					
Inspector Comment					
There is no rodent activity, but the holes need to be properly backfilled. Fall 2018.

View of waterward slope--burrow activity present.

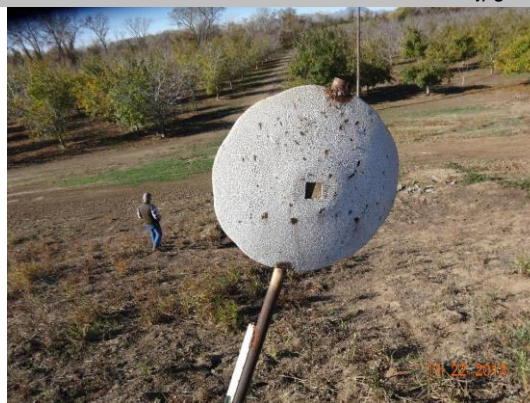
Photo 1 of 3 : UCIP_FA_2018_24825_44664.jpg

Comment Code						
Inspector Comment						
FS_ID:24825 DS_ID:21285 EP_NO: N/A Repair Type: Non-Urgent Crossing Status: Found UCIP Comments: 04/30/2013 Sediment blocking flap gate and screw gate--recommend removing material. Dense burrow activity present along levee slopes (large holes visible on landward side)--recommend addressing issue. This crossing is referenced in the USACE Periodic Inspection as item USACE_CESPK_HON2_2013_p_0169. (DWR UCIP - O. Magana) FIELD_STRUCT_DESC: 30-inch corrugated metal gravity drainage pipe through the levee, 19.5 feet below the crown. Corrugated metal cutoff wall around the pipe at each shoulder. Flap gate on the waterside (WS) end. Slide gate on the landside (LS) end. Concrete headwall at each end. [Additional Reference(s): DWR Levee Log, 2005. USACE Sacramento O&M Manual 151, May 1953, (Station 277+00)]. FS Date: 4/30/2013

Marker visible on waterward side.

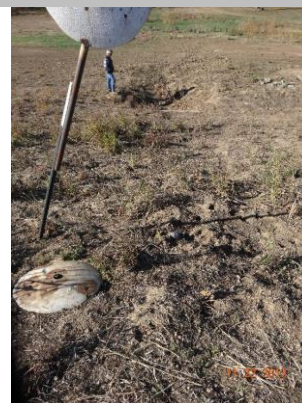
Photo 2 of 3 : UCIP_FA_2018_24825_44663.jpg

View of waterward slope--burrow activity present.

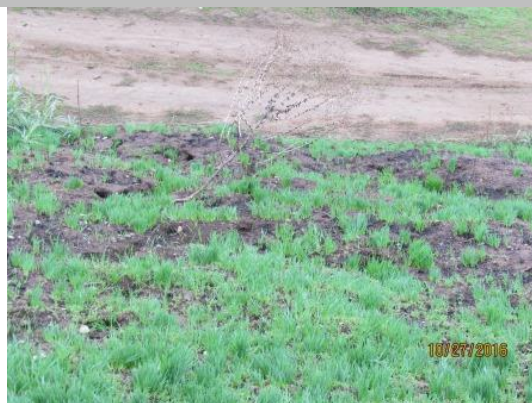
Photo 1 of 1 : FA_2018_RD0010_164_68_20180918_00027.jpg

LM Start	3.65	Rating **	M	Issue No.	68
LM End	3.65	Issue Type +	Ma	Location *	WS
Category	Earthen Levee			GPS Latitude/Longitude	
				Start	End
Item	Animal Control			39.216059 °	39.216059 °
				-121.610815 °	-121.610815 °
DWR ID	DWR_RD0010_02_f_2013_68				
Comment Code					
A3 : No rodents visible, but rodent burrows visible; need to backfill and compact or grout burrows.					
Inspector Comment					
No rodent activity but holes need to be properly backfilled. Fall 2018.

View of rodent holes on waterside slope, no evidence of rodent activity Spring 2017.

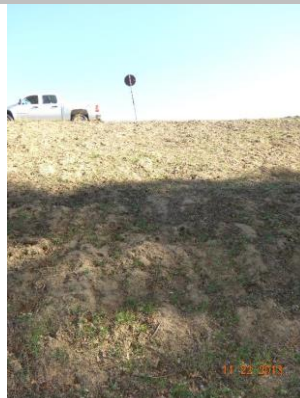
Photo 2 of 3 : UCIP_FA_2018_24826_44668.jpg

Comment Code						
Inspector Comment						
FS_ID:24826						
DS_ID:21286						
EP_NO: N/A						
Repair Type: Non-Urgent						
Crossing Status: Found						
UCIP Comments: 04/30/2013 Deformation observed on the top wall of pipe at the entrance of landward side--need to contact owner to address issue. This crossing is referenced in the USACE Periodic Inspection as item USACE_CESPK_HON2_2013_p_0180. (DWR UCIP - O. Magana)						
FIELD_STRUCT_DESC: 30-inch corrugated metal gravity drainage pipe through the levee, 21.5 feet below the crown. Corrugated metal cutoff walls around the pipe at each shoulder. Flap gate on the waterside (WS) end. Slide gate on the landside (LS) end. Concrete headwall at each end. [Additional Reference(s): DWR Levee Log, 2005. USACE Sacramento O&M Manual 151, May 1953, (Station 294+84)].						
FS Date: 4/30/2013

View of waterward slope.

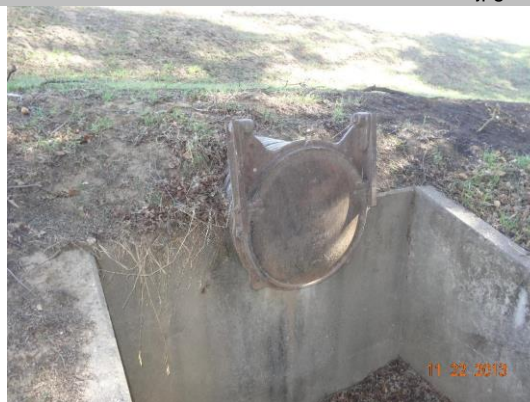
Photo 3 of 3 : UCIP_FA_2018_24826_44673.jpg

View of flapgate on concrete head wall on waterward side.

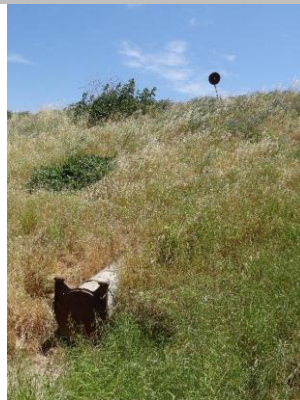
Photo 1 of 3 : UCIP_FA_2018_24751_44375.jpg

Comment Code						
Inspector Comment						
FS_ID:24751 DS_ID:21288 EP_NO: N/A Repair Type: Non-Urgent Crossing Status: Found UCIP Comments: 04/30/2013 Need to updated photos showing cleared slopes. This crossing is referenced in the USACE Periodic Inspection as item USACE_CESPK_HON2_2013_p_0193. (DWR UCIP - O. Magana) FIELD_STRUCT_DESC: 24-inch corrugated metal gravity drainage pipe through the levee, 19 feet below the crown. Corrugated metal cutoff wall around the pipe at each shoulder. Flap gate on the waterside (WS) end. Slide gate on the landside (LS). Concrete headwall, saddle, and apron on the WS end. [Additional Reference(s): DWR Levee Log, 2005. USACE Sacramento O&M Manual 151, May 1953, (Station 322+25)]. FS Date: 4/30/2013

View of waterward side--dense vegetation on slope.

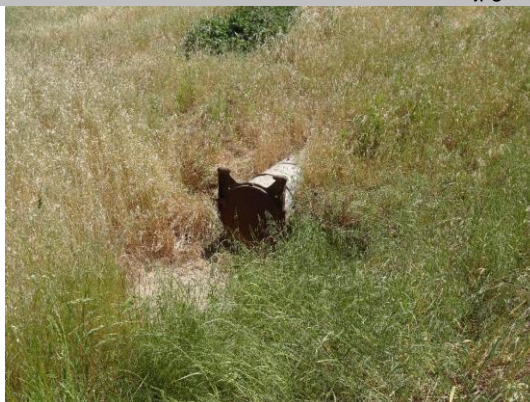
Photo 2 of 3 : UCIP_FA_2018_24751_44376.jpg

View of flap gate on waterward side.

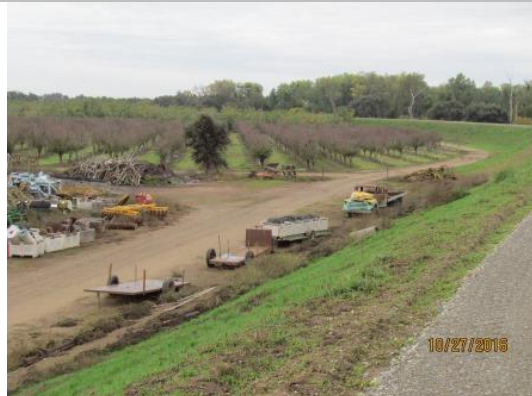
Photo 2 of 2 : FA_2018_RD0010_164_31_20180918_00007.jpg

LM Start	4.44	Rating **	M	Issue No.	31 (cont)	
LM End	4.48	Issue Type +	En	Location *	LS	
Category	Earthen Levee			GPS Latitude/Longitude		
				Start		End
Item	Encroachments			39.226946 °		39.227445 °
				-121.613048 °		-121.612718 °
DWR ID	DWR_RD0010_02_f_2015_31					
Comment Code						
EQ : Equipment						
Inspector Comment						
Remove equipment from levee toe that still exist, Fall 2018.

View of the equipment at the toe of the levee on the landward side of the levee looking downstream.

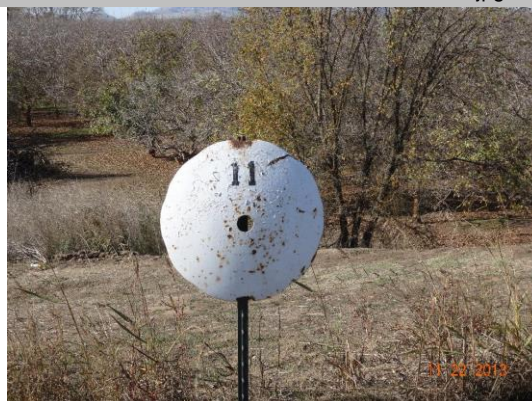
Photo 1 of 3 : UCIP_FA_2018_27774_51467.jpg

LM Start	4.78	Rating **	M	Issue No.	81	
LM End	4.78	Issue Type +	En	Location *		
Category	Supplemental			GPS Latitude/Longitude		
				Start	End	
Item	DWR UCIP Field Study			39.231251°	39.231251°	
				-121.614494°	-121.614494°	
DWR ID	21289					
Comment Code						
Inspector Comment						
FS_ID:27774						
DS_ID:21289						
EP_NO: N/A						
Repair Type: Non-Urgent						
Crossing Status: Indicator Found						
UCIP Comments: 04/30/2013 Sediment build-up inside and at the opening pipe. This crossing is referenced in the USACE Periodic Inspection as item USACE_CESPK_HON2_2013_p_0206. (DWR UCIP - O. Magana)						
FIELD_STRUCT_DESC: 30-inch gravity drainage pipe of an unknown material through the levee, 20 feet below the crown. Flap gate on the waterside (WS) end. Slide gate on the landside (LS) end. [Additional Reference(s): DWR Levee Log, 2005].						
FS Date: 4/30/2013

Marker visible on waterward shoulder, Reference ID No. 11 for crossing.

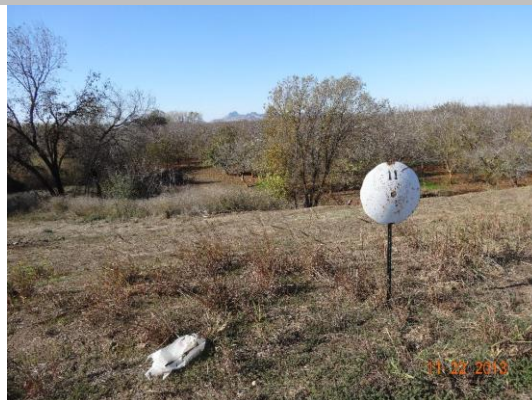
Photo 2 of 3 : UCIP_FA_2018_27774_51470.jpg

View of waterward side.

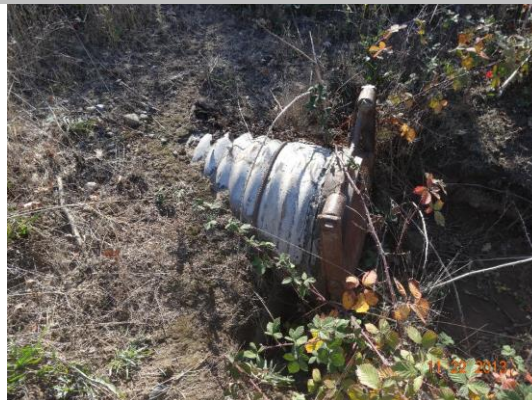
Photo 3 of 3 : UCIP_FA_2018_27774_51469.jpg

View of flap gate located on waterward side.

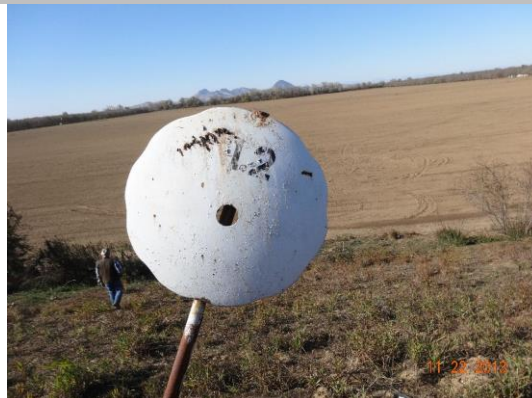
Photo 1 of 3 : UCIP_FA_2018_24828_44680.jpg

Comment Code						
Inspector Comment						
FS_ID:24828						
DS_ID:21290						
EP_NO: N/A						
Repair Type: No Action Needed						
Crossing Status: Found						
UCIP Comments: 04/30/2013 This crossing is referenced in the						
USACE Periodic Inspection as item						
USACE_CESPK_HON2_2013_p_0212. (DWR UCIP - O. Magana)						
FIELD_STRUCT_DESC: 30-inch corrugated metal gravity drainage pipe						
through the levee, 20 feet below the crown. Corrugated metal cutoff wall						
around the pipe at each shoulder. Flap gate on the waterside (WS) end.						
Slide gate on the landside (LS). Concrete headwall, saddle, and apron						
on the WS end. Pipe discharges into a 5-foot by 5-foot concrete						
distribution box at the WS toe. [Additional Reference(s): DWR Levee						
Log, 2005. USACE Sacramento O&M Manual 151, May 1953, (Station						
354+96)].						
FS Date: 4/30/2013

View of marker located on waterward shoulder--crossing referenced as No. 12.

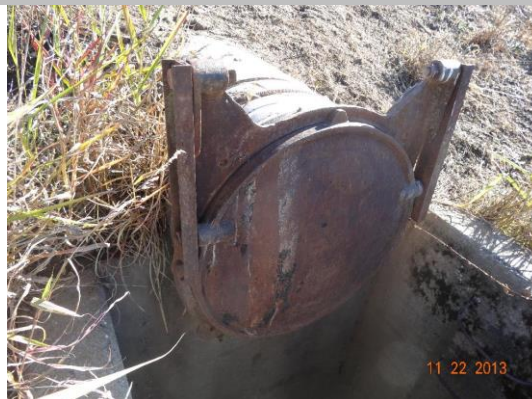
Photo 2 of 3 : UCIP_FA_2018_24828_44684.jpg

View of flap gate located on waterward side.

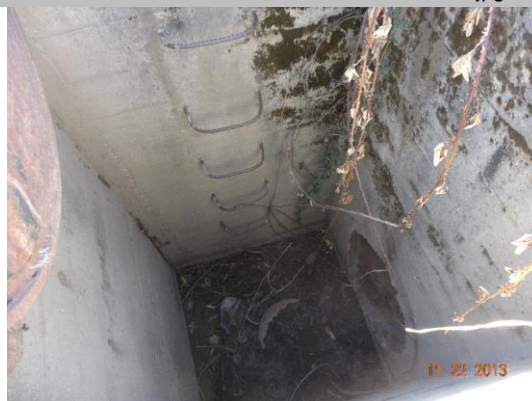
Photo 3 of 3 : UCIP_FA_2018_24828_44683.jpg

Inside view of concrete distribution box.

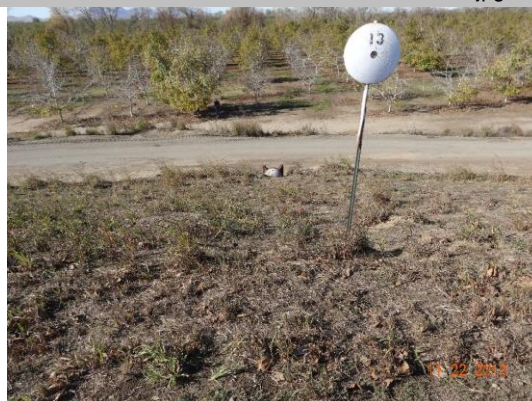
Photo 1 of 3 : UCIP_FA_2018_27793_51514.jpg

Comment Code						
Inspector Comment						
FS_ID:27793						
DS_ID:21291						
EP_NO: N/A						
Repair Type: Non-Urgent						
Crossing Status: Found						
UCIP Comments: 04/30/2013 Need to contact owner to remove debris inside concrete distribution box and on slope. This crossing is referenced in the USACE Periodic Inspection as item USACE_CESPK_HON2_2013_p_0244. (DWR UCIP - O. Magana)						
FIELD_STRUCT_DESC: 30-inch corrugated metal gravity drainage pipe through the levee, 17.3 feet below the crown. Corrugated metal cutoff wall around the pipe at each shoulder. Flap gate on the waterside (WS) end. Slide gate on the landside (LS) end. Concrete headwall at each end. [Additional Reference(s): DWR Levee Log, 2005. USACE Sacramento O&M Manual 151, May 1953, (Station 413+81)].						
FS Date: 4/30/2013

View of marker located on waterward shoulder, pipe is reference as No. 13.

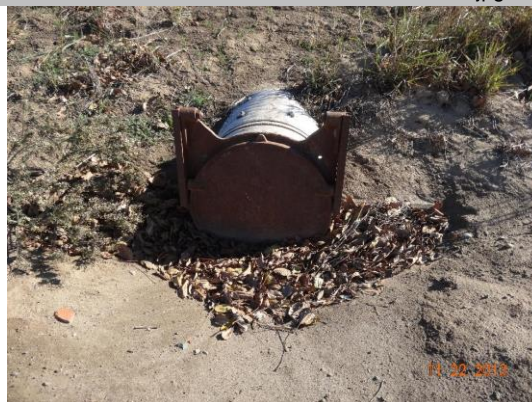
Photo 2 of 3 : UCIP_FA_2018_27793_51517.jpg

View of flap gate located on waterward side.

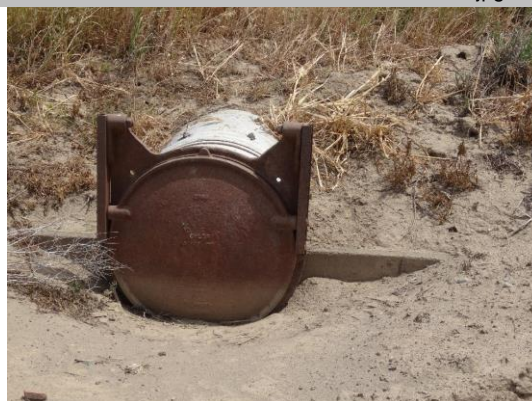
Photo 3 of 3 : UCIP_FA_2018_27793_51513.jpg

Flap gate and concrete headwall visible on waterward side.

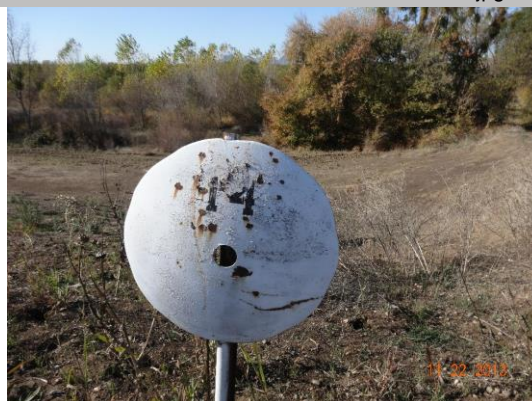
Photo 1 of 3 : UCIP_FA_2018_50059_44693.jpg

FS_ID:50059
DS_ID:21293
EP_NO: N/A
Repair Type: Non-Urgent
Crossing Status: Indicator Found
UCIP Comments: 7/01/2016 Crossing is blocked by sediment and debris on both WS and LS. Screw gate is missing on LS. (DWR UCIP - omagana)4/30/2013 Both openings of crossing are blocked by sediment--screw gate is damage. Recommend notifying owner to repair screw gate and remove sediment build-up blocking openings. This crossing is referenced in the USACE Periodic Inspection as item USACE_CESPK_HON2_2013_p_0295. (DWR UCIP - omagana)
FIELD_STRUCT_DESC: 24-inch corrugated metal gravity drainage pipe through the levee, 13 feet below the crown. Corrugated metal cutoff wall around the pipe at each shoulder. Flap gate on the waterside (WS) end. Slide gate on the landside (LS). Concrete headwall, saddle, and apron on the WS end. [Additional Reference(s): DWR Levee Log, 2005. USACE Sacramento O&M Manual 151, May 1953, (Station 471+21)].

Marker visible on WS shoulder, crossing referenced as No. 14.

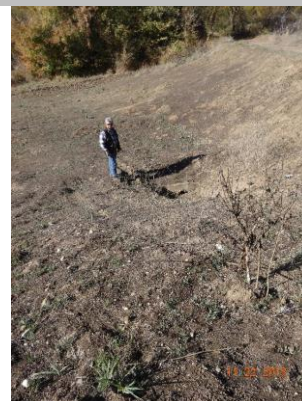
Photo 2 of 3 : UCIP_FA_2018_50059_44692.jpg

View of WS slope.

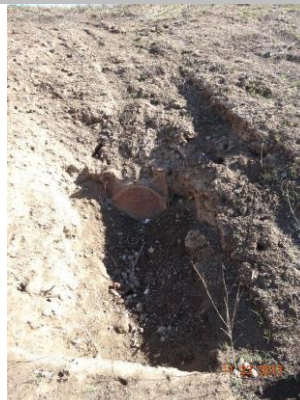
Photo 3 of 3 : UCIP_FA_2018_50059_44697.jpg

View of flap gate and concrete distribution box on WS.

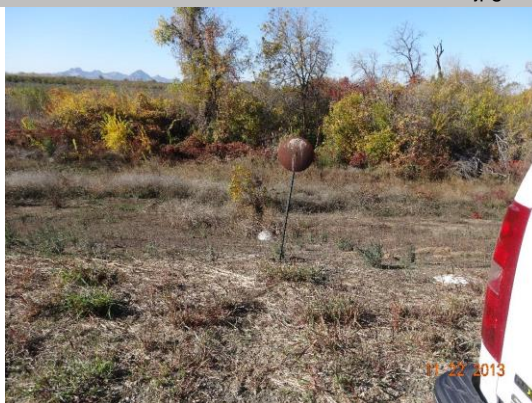
Photo 1 of 3 : UCIP_FA_2018_24831_44700.jpg

Visible marker located on waterward shoulder--no id number noted.

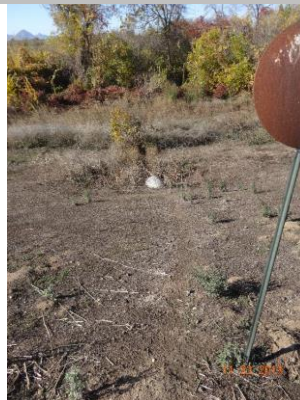
Photo 2 of 3 : UCIP_FA_2018_24831_44699.jpg

View of waterward slope.

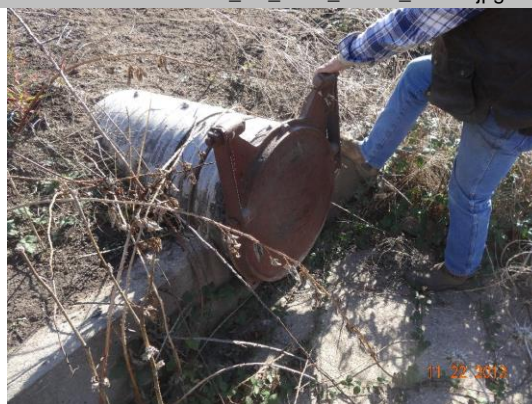
Photo 3 of 3 : UCIP_FA_2018_24831_44698.jpg

Flap gate visible on waterward side.

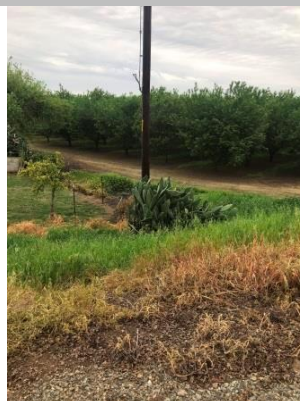
LM Start	8.02	Rating **	M	Issue No.	41
LM End	8.02	Issue Type +	En	Location *	LS
Category	Earthen Levee			GPS Latitude/Longitude	
				Start	End
Item	Vegetation			39.274334 °	39.274334 °
				-121.611986 °	-121.611986 °
DWR ID	DWR_RD0010_02_s _ 2018_41				
Comment Code					
V6 : Landscaping					
Inspector Comment					
Remove landscape bush from levee toe.

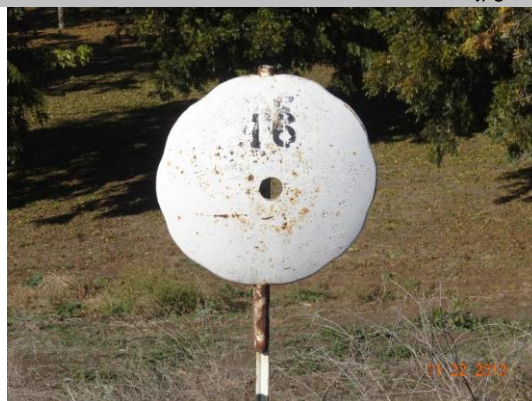
Photo 1 of 3 : UCIP_FA_2018_24832_44705.jpg

Marker visible on waterward shoulder, crossing is referenced as No. 16.

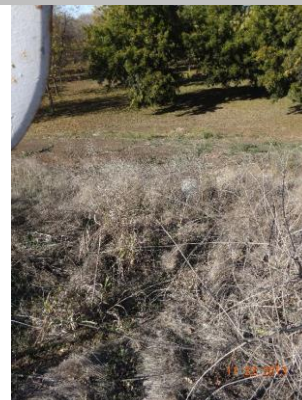
Photo 2 of 3 : UCIP_FA_2018_24832_44704.jpg

View of waterward side.

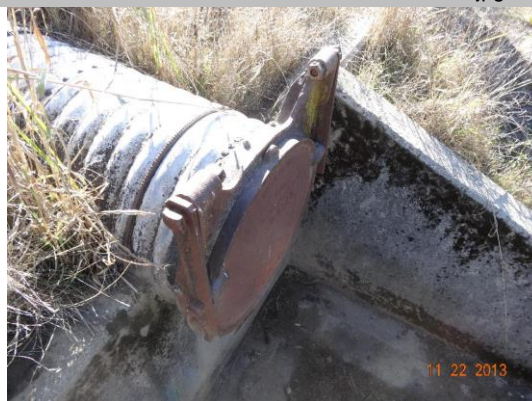
Photo 3 of 3 : UCIP_FA_2018_24832_44703.jpg

View of flap gate located on waterward side.

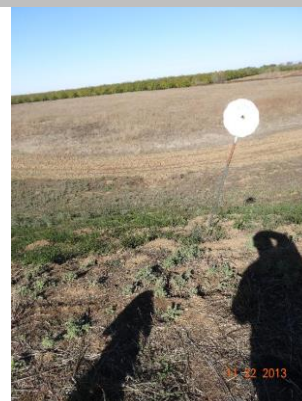
Photo 1 of 3 : UCIP_FA_2018_27775_51473.jpg

Comment Code					
Inspector Comment					
FS_ID:27775					
DS_ID:21296					
EP_NO: N/A					
Repair Type: Non-Urgent					
Crossing Status: Found					
UCIP Comments: 04/30/2013 Sediment build-up at the inlet--recommend clearing sediment. This crossing is referenced in the USACE Periodic Inspection as item					
USACE_CESPK_HON2_2013_p_0348. (DWR UCIP - O. Magana)					
FIELD_STRUCT_DESC: 30-inch corrugated metal gravity drainage pipe through the levee, 23 feet below the crown. Corrugated metal cutoff wall around the pipe at each shoulder. Flap gate on the waterside (WS) end. Slide gate on the landside (LS) end. Concrete headwall at each end. Metal marker on the WS shoulder. [Additional Reference(s): DWR Levee Log, 2005. USACE Sacramento O&M Manual 151, May 1953, (Station 551+96)].					
FS Date: 4/30/2013

View of waterward side.

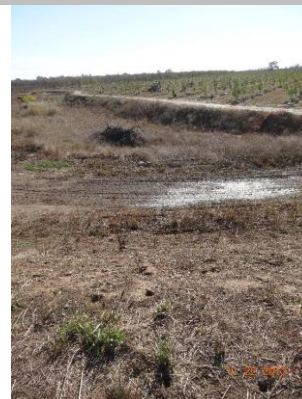
Photo 2 of 3 : UCIP_FA_2018_27775_51472.jpg

View of landward side.

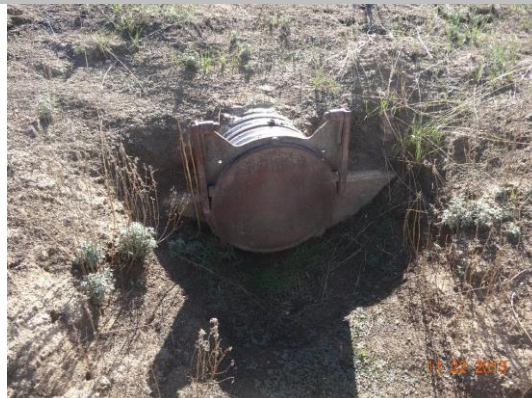
Photo 3 of 3 : UCIP_FA_2018_27775_51477.jpg

View of flap gate visible on waterward side.

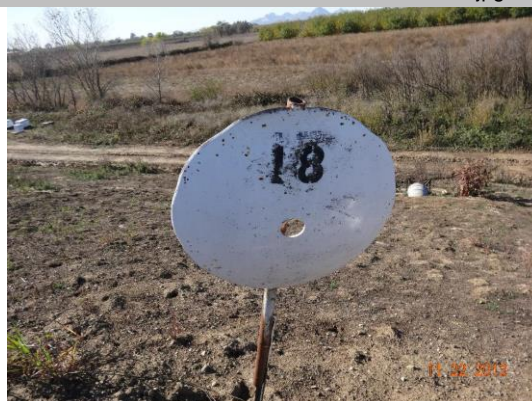
Photo 1 of 3 : UCIP_FA_2018_24834_44715.jpg

Comment Code						
Inspector Comment						
FS_ID:24834 DS_ID:21297 EP_NO: N/A Repair Type: Non-Urgent Crossing Status: Found UCIP Comments: 04/30/2013 Slide gate missing on landward side. Need to contact owner to determine status of crossing. This crossing is referenced in the USACE Periodic Inspection as item USACE_CESPK_HON2_2013_p_0367. (DWR UCIP - O. Magana) FIELD_STRUCT_DESC: 24-inch corrugated metal gravity drainage pipe through the levee, 14 feet below the crown. Corrugated metal cutoff wall around the pipe at each shoulder. Flap gate on the waterside (WS) end. Slide gate on the landside (LS), slide gate missing. Concrete headwall, saddle, and apron on the WS end. 6-foot by 6-foot concrete splash apron at the WS toe. [Additional Reference(s): DWR Levee Log, 2005. USACE Sacramento O&M Manual 151, May 1953, (Station 565+74)]. FS Date: 4/30/2013

Marker visible on waterward shoulder, crossing is referenced as No. 18.

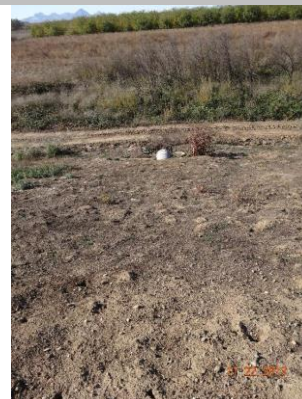
Photo 2 of 3 : UCIP_FA_2018_24834_44714.jpg

View of waterward side.

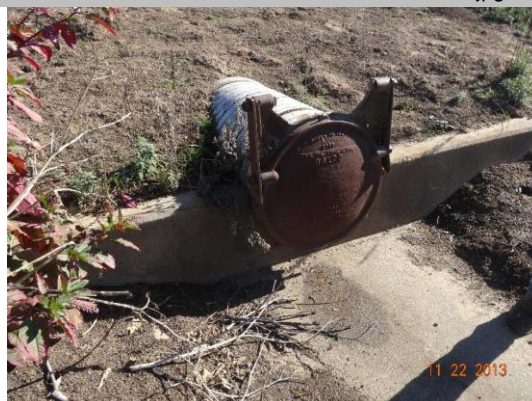
Photo 3 of 3 : UCIP_FA_2018_24834_44716.jpg

View of flap gate visible on waterward side.

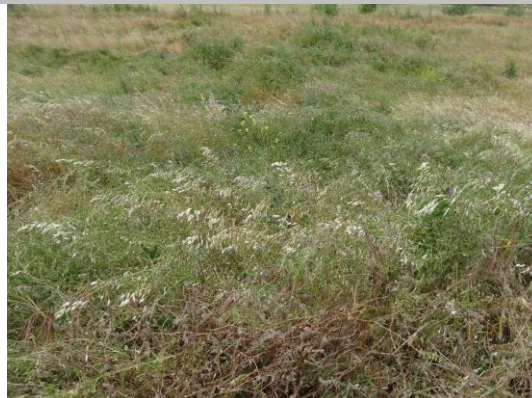
Photo 1 of 3 : UCIP_FA_2018_24768_44450.jpg

Comment Code						
Inspector Comment						
FS_ID:24768 DS_ID:21298 EP_NO: N/A Repair Type: Non-Urgent Crossing Status: Found UCIP Comments: 04/30/2013 Crossing is buried--found indicators of concrete headwall. Need to contact owner to determine status of crossing. This crossing is referenced in the USACE Periodic Inspection as item USACE_CESPK_HON2_2013_p_0378. (DWR UCIP - O. Magana) FIELD_STRUCT_DESC: 24-inch corrugated metal gravity drainage pipe through the levee, 13 feet below the crown. Corrugated metal cutoff wall around the pipe at each shoulder. Flap gate on the waterside (WS) end. Slide gate on the landside (LS) end. Concrete headwall at each end. Metal marker on the WS slope. [Additional Reference(s): DWR Levee Log, 2005. USACE Sacramento O&M Manual 151, May 1953, (Station 576+75)]. FS Date: 4/30/2013

View of waterward slope.

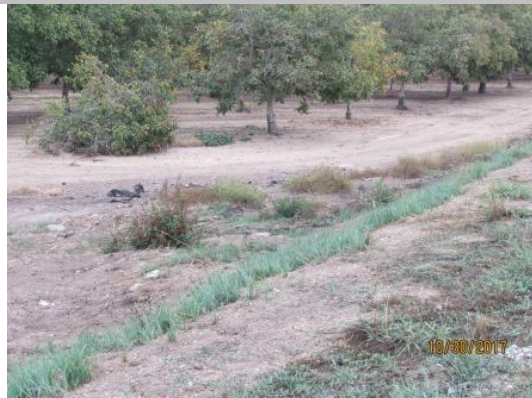
Photo 1 of 1 : FA_2018_RD0010_164_69_20180918_00028.jpg

LM Start	9.26	Rating **	A/W	Issue No.	69
LM End	9.26	Issue Type +	En	Location *	LS
Category	Earthen Levee			GPS Latitude/Longitude	
				Start	End
Item	Encroachments			39.285845 °	39.285845 °
				-121.600362 °	-121.600362 °
DWR ID	DWR_RD0010_02_s_2016_69				
Comment Code					
PR : Prunings					
Inspector Comment					
Remove prunings from levee toe.

View looking downstream landside where prunings have been removed, Fall 2017.

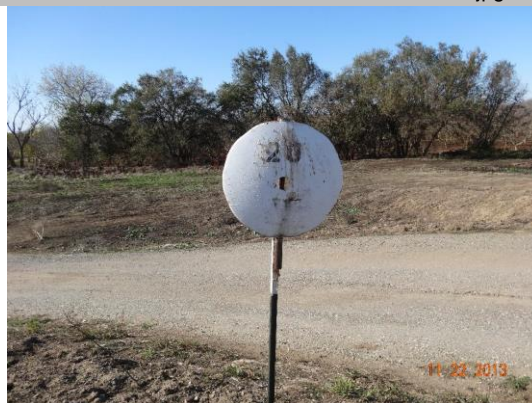
Photo 1 of 3 : UCIP_FA_2018_24769_44454.jpg

Comment Code						
Inspector Comment						
FS_ID:24769 DS_ID:21299 EP_NO: N/A Repair Type: Non-Urgent Crossing Status: Found UCIP Comments: 04/30/2013 Need to contact owner. Need to clear debris from concrete distribution box on waterward and remove debris blocking landward side.This crossing is referenced in the USACE Periodic Inspection as item USACE_CESPK_HON2_2013_p_0383. (DWR UCIP - O. Magana) FIELD_STRUCT_DESC: 24-inch corrugated metal gravity drainage pipe through the levee, 12 feet below the crown. Corrugated metal cutoff wall around the pipe at each shoulder. Flap gate on the waterside (WS) end. Slide gate on the landside (LS). Concrete headwall, saddle, and apron on the WS end. Metal marker on the WS shoulder. [Additional Reference(s): DWR Levee Log, 2005. USACE Sacramento O&M Manual 151, May 1953, (Station 582+72)]. FS Date: 4/30/2013

Marker visible on waterward side shoulder, crossing is referenced as No. 20.

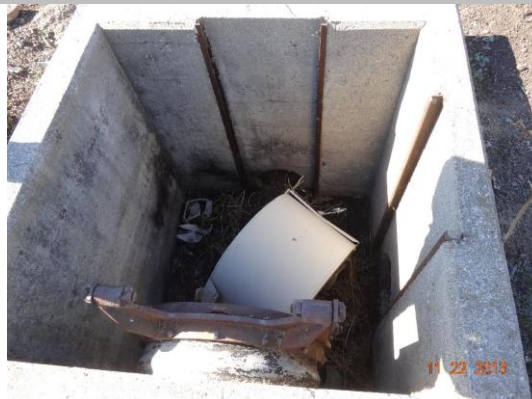
Photo 3 of 3 : UCIP_FA_2018_24769_44452.jpg

Comment Code						
Inspector Comment						
FS_ID:24769 DS_ID:21299 EP_NO: N/A Repair Type: Non-Urgent Crossing Status: Found UCIP Comments: 04/30/2013 Need to contact owner. Need to clear debris from concrete distribution box on waterward and remove debris blocking landward side.This crossing is referenced in the USACE Periodic Inspection as item USACE_CESPK_HON2_2013_p_0383. (DWR UCIP - O. Magana) FIELD_STRUCT_DESC: 24-inch corrugated metal gravity drainage pipe through the levee, 12 feet below the crown. Corrugated metal cutoff wall around the pipe at each shoulder. Flap gate on the waterside (WS) end. Slide gate on the landside (LS). Concrete headwall, saddle, and apron on the WS end. Metal marker on the WS shoulder. [Additional Reference(s): DWR Levee Log, 2005. USACE Sacramento O&M Manual 151, May 1953, (Station 582+72)]. FS Date: 4/30/2013

View of concrete distribution box located on waterward side.

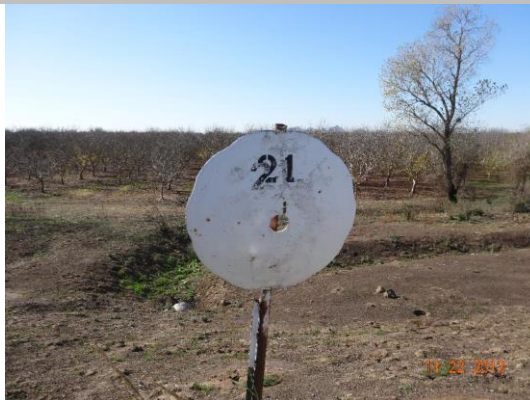
Photo 1 of 3 : UCIP_FA_2018_24835_44721.jpg

Marker visible on waterward shoulder, crossing referenced as No. 21.

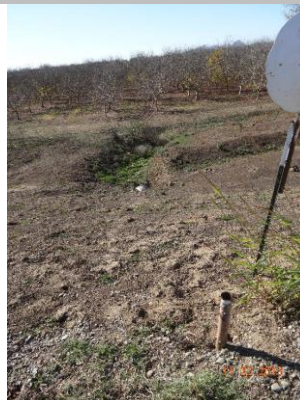
Photo 2 of 3 : UCIP_FA_2018_24835_44720.jpg

View of waterward side.

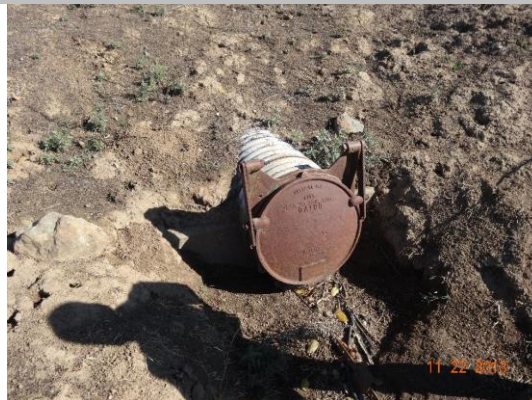
Photo 3 of 3 : UCIP_FA_2018_24835_44725.jpg

View of flap gate located on waterward side.

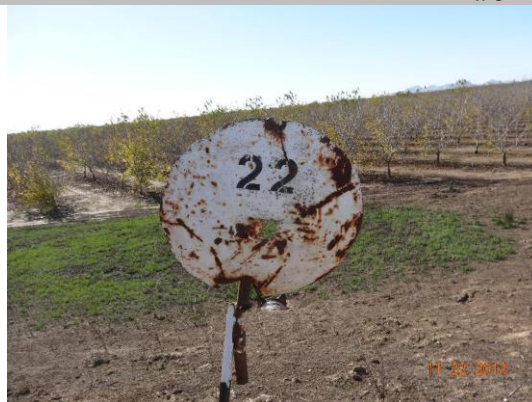
Photo 1 of 3 : UCIP_FA_2018_27776_51478.jpg

Comment Code						
Inspector Comment						
FS_ID:27776						
DS_ID:21301						
EP_NO: N/A						
Repair Type: Non-Urgent						
Crossing Status: Found						
UCIP Comments: 04/30/2013 Recommend removing debris blocking slide gate on landward side. This crossing is referenced in the USACE Periodic Inspection as item USACE_CESPK_HON2_2013_p_0402.						
(DWR UCIP - O. Magana)						
FIELD_STRUCT_DESC: 24-inch gravity drainage pipe of an unknown material through the levee, 13 feet below the crown. Flap gate on the waterside (WS) end. Slide gate on the landside (LS) end. Concrete headwall at the LS toe. [Additional Reference(s): DWR Levee Log, 2005].						
FS Date: 4/30/2013

Marker visible on waterward shoulder, crossing referenced as No. 22.

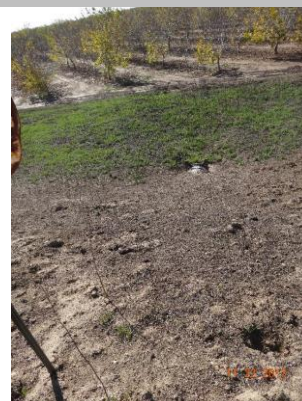
Photo 2 of 3 : UCIP_FA_2018_27776_51482.jpg

View of waterward side.

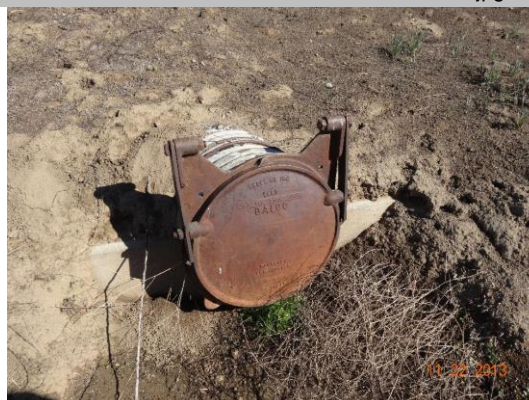
Photo 3 of 3 : UCIP_FA_2018_27776_51481.jpg

View of flap gate located on waterward toe.

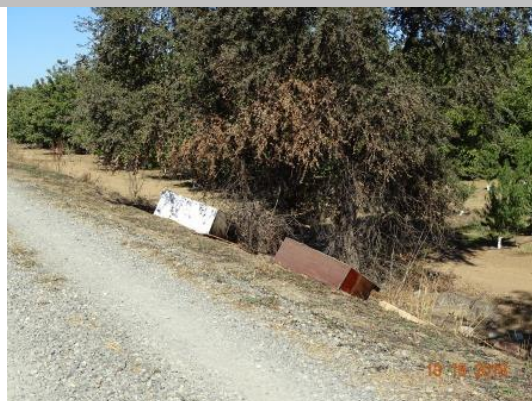
Photo 1 of 1 : FA_2018_RD0010_164_45_20181108_00098.jpg

LM Start	9.94	Rating **	M	Issue No.	45
LM End	9.94	Issue Type +	En	Location *	LS
Category	Earthen Levee			GPS Latitude/Longitude	
				Start	End
Item	Encroachments			39.293608 °	39.293608 °
				-121.606922 °	-121.606922 °
DWR ID	DWR_RD0010_02_f_2018_45				
Comment Code					
DE : Debris					
Inspector Comment					
Remove debris from levee slope, Fall 2018.

View looking at the landside levee slope where debris has been dumped, Fall 2018.

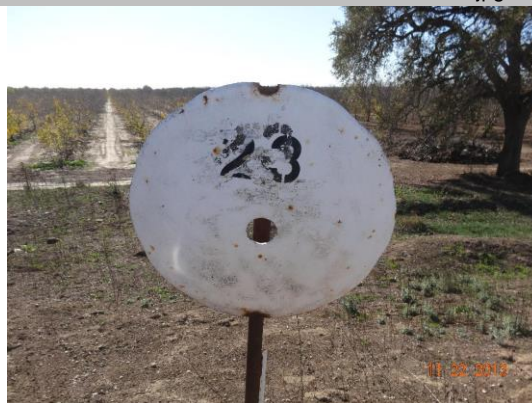
Photo 1 of 3 : UCIP_FA_2018_24837_44731.jpg

Marker visible on waterward shoulder, crossing is referenced as No. 23.

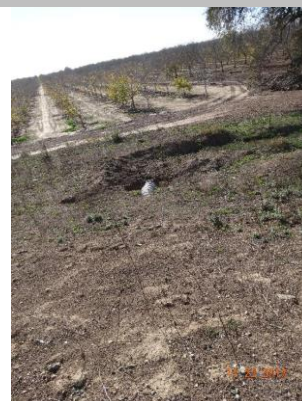
Photo 2 of 3 : UCIP_FA_2018_24837_44735.jpg

Overview of waterward side.

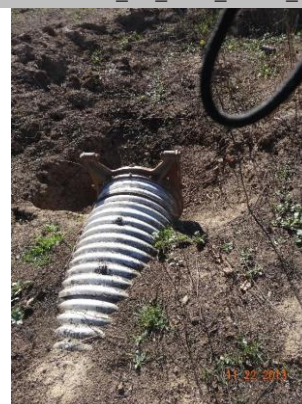
Photo 3 of 3 : UCIP_FA_2018_24837_44734.jpg

Pipe through waterward side.

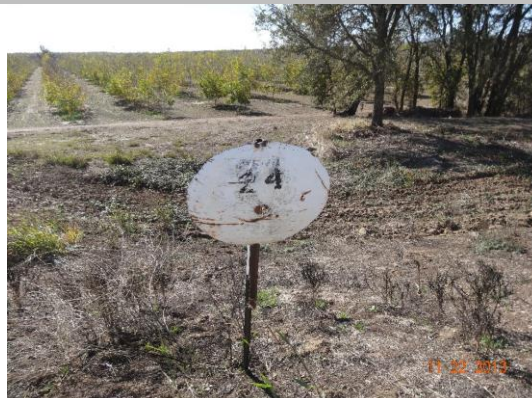
Photo 1 of 3 : UCIP_FA_2018_24838_44737.jpg

Comment Code						
Inspector Comment						
FS_ID:24838 DS_ID:21303 EP_NO: 1069 Repair Type: Non-Urgent Crossing Status: Found UCIP Comments: 04/30/2013 Unable to find the crossing on landward side--indicators found of crossing. Need to coordinate with owner to determine status of crossing. If crossing is no longer in use owner will need to contact the CVFPB to comply with Title 23. This crossing is referenced in the USACE Periodic Inspection as item USACE_CESPK_HON2_2013_p_0442. (DWR UCIP - O. Magana) FIELD_STRUCT_DESC: 24-inch steel gravity irrigation pipe through the levee, 13 feet below the crown. Concrete cutoff wall around the pipe at each shoulder. Flap gate and concrete headwall on the waterside (WS) end. Slide gate, concrete saddle, and apron on the landside (LS) end. (Plans for installation of a 24-inch corrugated iron pipe through the levee authorized under Permit No. 1069, 1946 - Pacific Ranch, care of Chas. J. Mathews). [Additional Reference(s): DWR Levee Log, 2005. USACE Sacramento O&M Manual 151, May 1953, (Station 638+00)]. FS Date: 4/30/2013

Marker visible on waterward shoulder, this crossing is reference as No. 24.

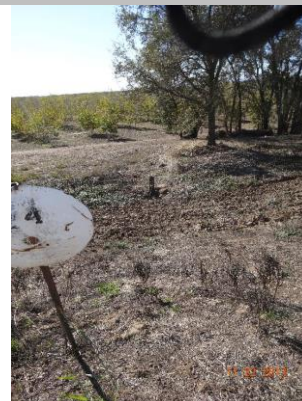
Photo 2 of 3 : UCIP_FA_2018_24838_44741.jpg

View of waterward side.

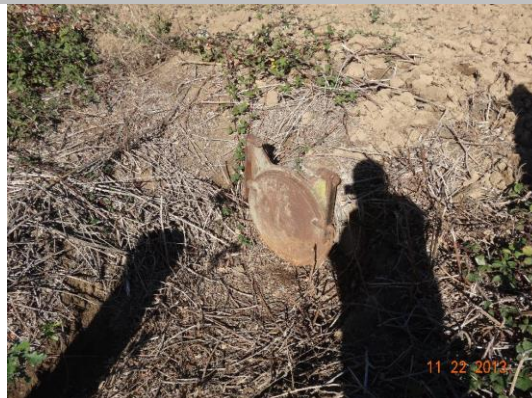
Photo 3 of 3 : UCIP_FA_2018_24838_44740.jpg

View of flap gate located on waterward side.

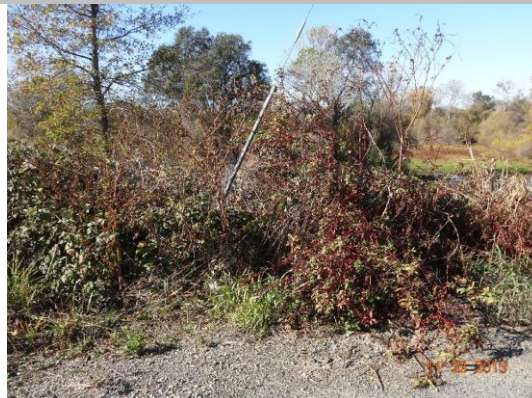
Photo 1 of 3 : UCIP_FA_2018_24839_44745.jpg

Comment Code						
Inspector Comment						
FS_ID:24839 DS_ID:21304 EP_NO: N/A Repair Type: Non-Urgent Crossing Status: Found UCIP Comments: 04/30/2013 Rip rap was used to stabilize the waterward slope during high water as a means of emergency repair--unable to determine storm event when repair was performed. Recommend obtaining records of the repair and to determine if crossing is still being used. Need to determine owner. Dense vegetation limits the inspector's visibility to identify signs of pipe failure (leaks) along the slope. Recommend removing vegetation along pipe alignment to conduct proper inspection of structure and appurtenances. This crossing is referenced in the USACE Periodic Inspection as item USACE_CESPK_HON2_2013_p_0458 and 460. (DWR UCIP - O. Magana) FIELD_STRUCT_DESC: 24-inch steel irrigation discharge pipe through the levee, 5 feet below the crown. Slide gate in a 36-inch concrete riser on the landside (LS) shoulder. Gate valve in a pump house on the waterside (WS) slope. Concrete headwall, saddle, and apron on the WS end. [Additional Reference(s): DWR Levee Log, 2005. USACE Sacramento O&M Manual 151, May 1953, (Station 655+65)]. FS Date: 4/30/2013

View of waterward shoulder behind vegetation is standpipe.

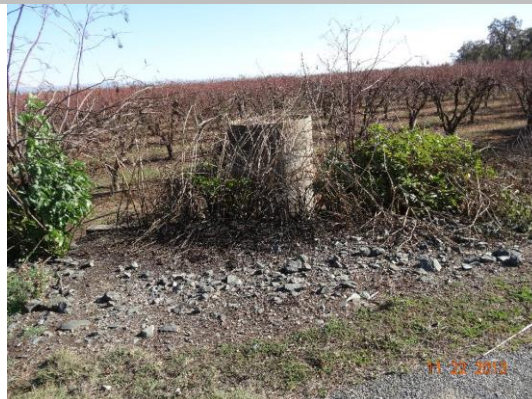
Photo 2 of 3 : UCIP_FA_2018_24839_44742.jpg

View of standpipe located on landward side.

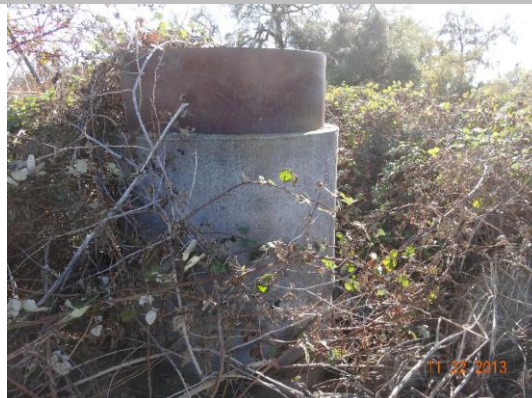
Photo 3 of 3 : UCIP_FA_2018_24839_44748.jpg

View of standpipe located on waterward side.

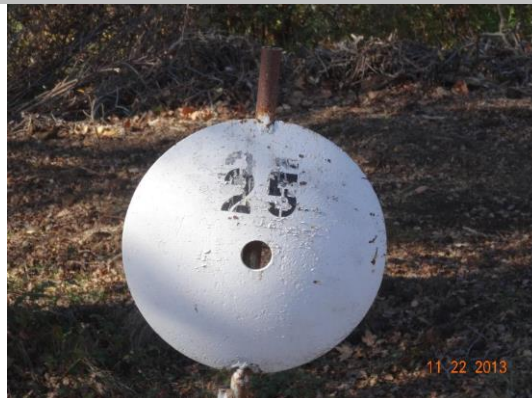
Photo 1 of 3 : UCIP_FA_2018_24840_44753.jpg

Comment Code						
Inspector Comment						
FS_ID:24840 DS_ID:21305 EP_NO: N/A Repair Type: Non-Urgent Crossing Status: Found UCIP Comments: 04/30/2013 Burrow activity--large holes found on landward side. Crossing on landward side is blocked. Recommend clearing headwall and crossing. Need to coordinate with owner to determine status of crossing. If crossing is no longer in use owner will need to contact the CVFPB to comply with Title 23. This crossing is referenced in the USACE Periodic Inspection as item USACE_CESPK_HON2_2013_p_0476. (DWR UCIP - O. Magana) FIELD_STRUCT_DESC: 24-inch corrugated metal gravity drainage pipe through the levee, 7.5 feet below the crown. Corrugated metal cutoff wall around the pipe at each shoulder. Flap gate on the waterside (WS) end. Concrete headwall at each toe. Saddle and apron on the WS. [Additional Reference(s): DWR Levee Log, 2005. USACE Sacramento O&M Manual 151, May 1953, (Station 674+73)]. FS Date: 4/30/2013

Marker visible on waterward side, crossing is referenced as No. 25.

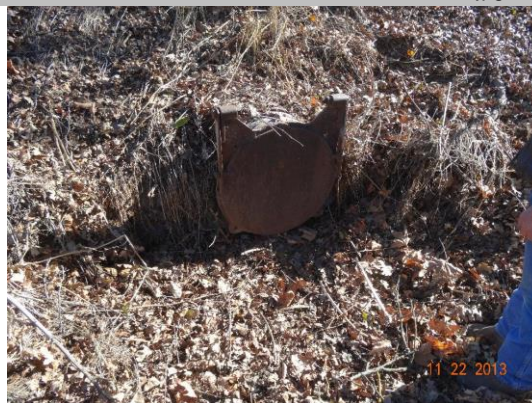
Photo 2 of 3 : UCIP_FA_2018_24840_44752.jpg

View of flap gate located on waterward side.

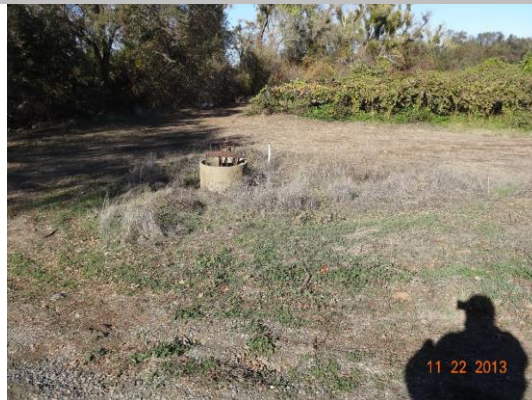
Photo 1 of 3 : UCIP_FA_2018_24841_44759.jpg

FS_ID:24841
DS_ID:21306
EP_NO: N/A
Repair Type: Non-Urgent
Crossing Status: Found
UCIP Comments: 05/01/2013 Debris found inside crossing-- recommend removing it. (DWR UCIP - O. Magana)
FIELD_STRUCT_DESC: 24-inch corrugated metal gravity drainage pipe through the levee, 6 feet below the crown. Slide gate in a concrete standpipe on the waterside (WS) end. [Additional Reference(s): DWR Levee Log, 2005].
FS Date: 5/1/2013

View of waterward side.

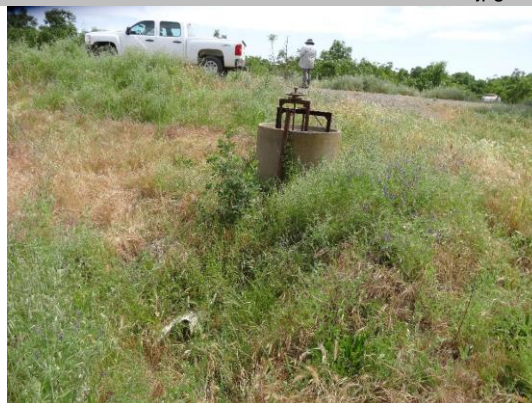
Photo 2 of 3 : UCIP_FA_2018_24841_44757.jpg

View of concrete standpipe and plastic pipe extension visible on waterward side.

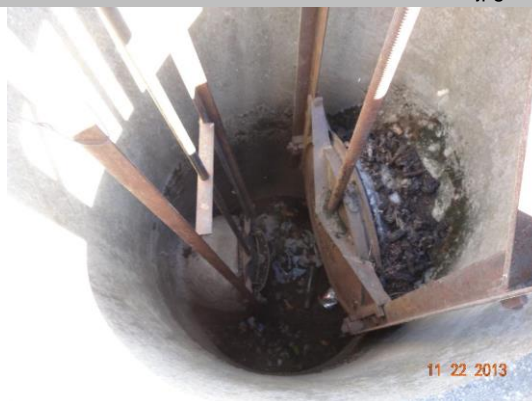
Photo 3 of 3 : UCIP_FA_2018_24841_44758.jpg

Inside view of concrete standpipe with 2 screw gates inside.

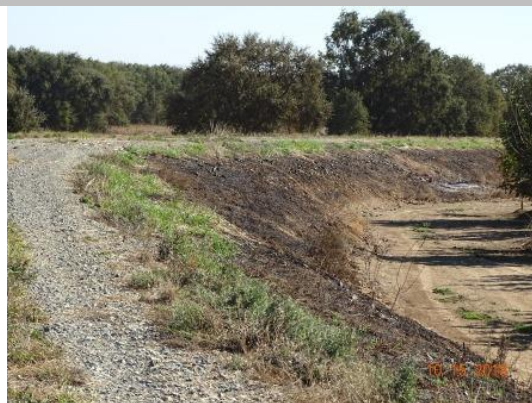
Photo 1 of 1 : FA_2018_RD0010_165_4_20181108_00014.jpg

LM Start	0.34	Rating **	A	Issue No.	4
LM End	2.80	Issue Type +	Ma	Location *	LS
Category	Earthen Levee			GPS Latitude/Longitude	
				Start	End
Item	Vegetation			39.310249 °	39.298557 °
				-121.610003 °	-121.569981 °
DWR ID	DWR_RD0010_03_f_2018_4				
Comment Code					
V1 : Control annual grass and weeds on the levee slopes and easements.					
Inspector Comment					
The annual vegetation is well maintained, Fall 2018.

View looking upstream landside at the well maintained vegetation, Fall 2018.

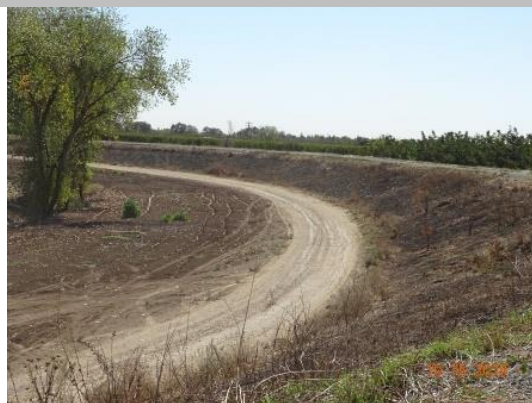
Photo 1 of 1 : FA_2018_RD0010_165_9_20181108_00017.jpg

LM Start	0.60	Rating **	A	Issue No.	9
LM End	2.80	Issue Type +	Ma	Location *	WS
Category	Earthen Levee			GPS Latitude/Longitude	
				Start	End
Item	Vegetation			39.310184°	39.298557°
				-121.605206°	-121.569981°
DWR ID	DWR_RD0010_03_f_2018_9				
Comment Code					
V1 : Control annual grass and weeds on the levee slopes and easements.					
Inspector Comment					
The annual vegetation is well maintained, Fall 2018.

View looking upstream waterside at the well maintained vegetation, Fall 2018.

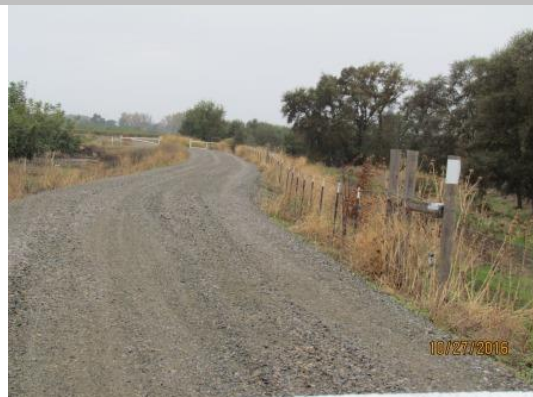
Photo 1 of 1 : FA_2018_RD0010_165_8_20180918_00003.jpg

LM Start	1.08	Rating **	M	Issue No.	8
LM End	1.21	Issue Type +	En	Location *	WS
Category	Earthen Levee			GPS Latitude/Longitude	
				Start	End
Item	Encroachments			39.307106 °	39.306422 °
				-121.597439 °	-121.595205 °
DWR ID	DWR_RD0010_03_s_2016_8				
Comment Code					
FE : Fence					
Inspector Comment					
Unpermitted fence on waterside levee hinge point.

View of an unpermitted fence on waterside levee hinge point.

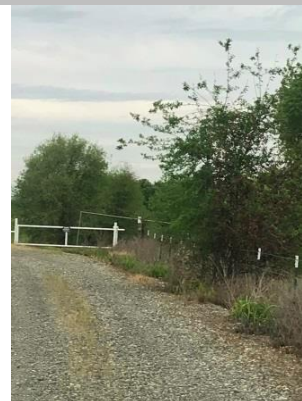
Photo 1 of 1 : FA_2018_RD0010_165_10_20180918_00004.jpg

LM Start	1.10	Rating **	M	Issue No.	10
LM End	1.10	Issue Type +	Ma	Location *	WS
Category	Earthen Levee			GPS Latitude/Longitude	
				Start	End
Item	Trim / Thin Trees			39.306995 °	39.306995 °
				-121.597116 °	-121.597116 °
DWR ID	DWR_RD0010_03_s_2018_10				
Comment Code					
T2 : Thin trees to allow visibility of the ground and room to flood fight.					
Inspector Comment					
Tree needs to be trimmed for access and visibility, Spring 2018.

View looking downstream waterside of a tree that needs to be trimmed for access and visibility, Spring 2018.

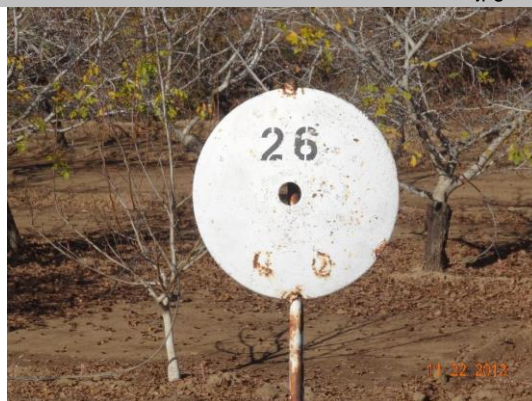
Photo 1 of 3 : UCIP_FA_2018_24842_44764.jpg

Comment Code						
Inspector Comment						
FS_ID:24842						
DS_ID:21307						
EP_NO: N/A						
Repair Type: Non-Urgent						
Crossing Status: Found						
UCIP Comments: 05/01/2013 Sediment deposit inside pipe--Need to coordinate with owner to determine status of crossing. If crossing is no longer in use owner will need to contact the CVFPB to comply with Title 23. (DWR UCIP - O. Magana)						
FIELD_STRUCT_DESC: 24-inch corrugated metal gravity drainage pipe through the levee, 15 feet below the crown. Corrugated metal cutoff wall around the pipe at each shoulder. Flap gate on the waterside (WS) end. Slide gate on the landside (LS) end. Concrete headwall at each toe.						
[Additional Reference(s): DWR Levee Log, 2005. USACE Sacramento O&M Manual 151, May 1953, (Station 134+06)].						
FS Date: 5/1/2013

Marker visible on waterward side--No. 26.

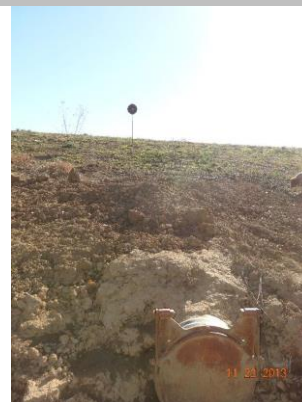
Photo 2 of 3 : UCIP_FA_2018_24842_44762.jpg

View of waterward slope.

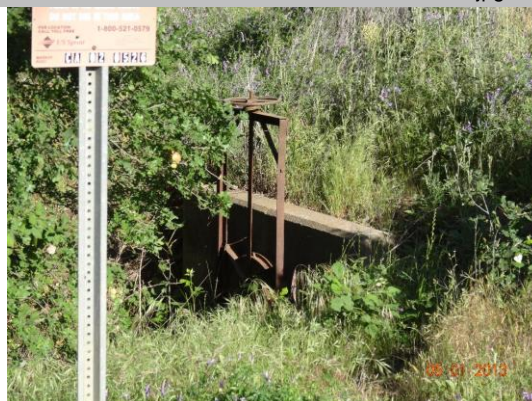
Photo 1 of 2 : UCIP_FA_2018_24883_44820.jpg

Comment Code						
Inspector Comment						
FS_ID:24883 DS_ID:21308 EP_NO: N/A Repair Type: Non-Urgent Crossing Status: Found UCIP Comments: 05/01/2013 Dense vegetation limits the inspector's visibility to identify signs of pipe failure (leaks) along the slope. Recommend removing vegetation along pipe alignment to conduct proper inspection of structure and appurtances. (DWR UCIP - O. Magana) FIELD_STRUCT_DESC: 24-inch corrugated metal gravity drainage pipe through the levee, 12 feet below the crown. Corrugated metal cutoff wall around the pipe at each shoulder. Flap gate on the waterside (WS) end. Slide gate on the landside (LS) end. Concrete headwall at the LS toe. [Additional Reference(s): DWR Levee Log, 2005. USACE Sacramento O&M Manual 151, May 1953, (Station 192+33)]. FS Date: 5/1/2013

View of slide gate and concrete headwall located on landward side.
